Manhole Inspection Summary

Manhole # S47KK_034MH

Insp Date: **5/2/08 11:17 AM**

Location Address: **Lanvale St**

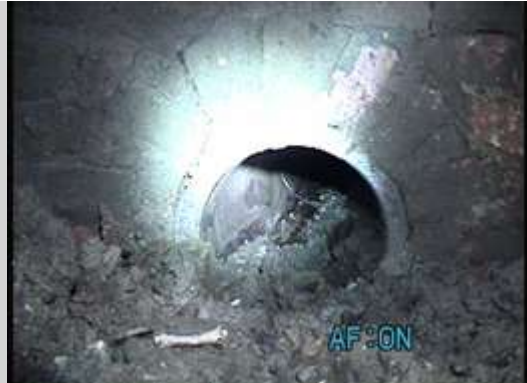
12 O'Clock Outflow

8 in. Circular Gravity Sewer
Pipe Out @ 12 O'Clock

Infiltration: **None** Pipe Seal Cond: **Sound**
